# **INSTALLATION INSTRUCTIONS**

**TOTALINER SLIDING CARGO TRAY FOR FULL-SIZE PICKUPS**

**(FORD F150 5.5'&6.5' Bed 15+/DODGE RAM 1500 5.5'Bed 09+/CHEVY  
SILVERADO 1500 5.9' Bed 15+/TOYOTA TUNDRA 5.5' Bed 14+)**

**PART # BSCP01B**

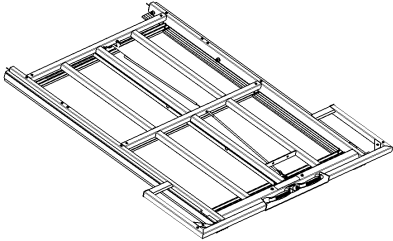
NO.	QTY	NAME	NO.	QTY	NAME
①	1

Base Of Slide Tray	②	1

Side Plate (L)
③	1

Side Plate (R)	④	1

Rear Plate
⑤	1

Front Base Plate	⑥	1

Rear Base Plate
⑦	1

Red Decoration Plate	⑧	6

Type D Buckle

⑨	6

Bracket For Type Buckle	⑩	3

Tape
<b>Hardware List:</b>					
⑪	16	Hex Flat Head Bolt M6_20	⑫	12	Lock Washer D6
⑬	24	Large Flat Washer D6 (6*18*1.6mm)	⑭	12	Hex Socket Button Head Bolt M6_16
⑮	12	Cap Nut M6	⑯	13	Hex Flange Nut M6
⑰	13	Assembly Bolt M6_20	⑱	1	Allen Wrench S=4
⑲	4	Hex Bolt (Full Thread) M10_65	⑳	8	Extra Large Washer D12 (12*44*4mm)
㉑	4	Lock Washer D10	㉒	4	Hex Nut M10
㉓	4	Plastic Washer φ16×12

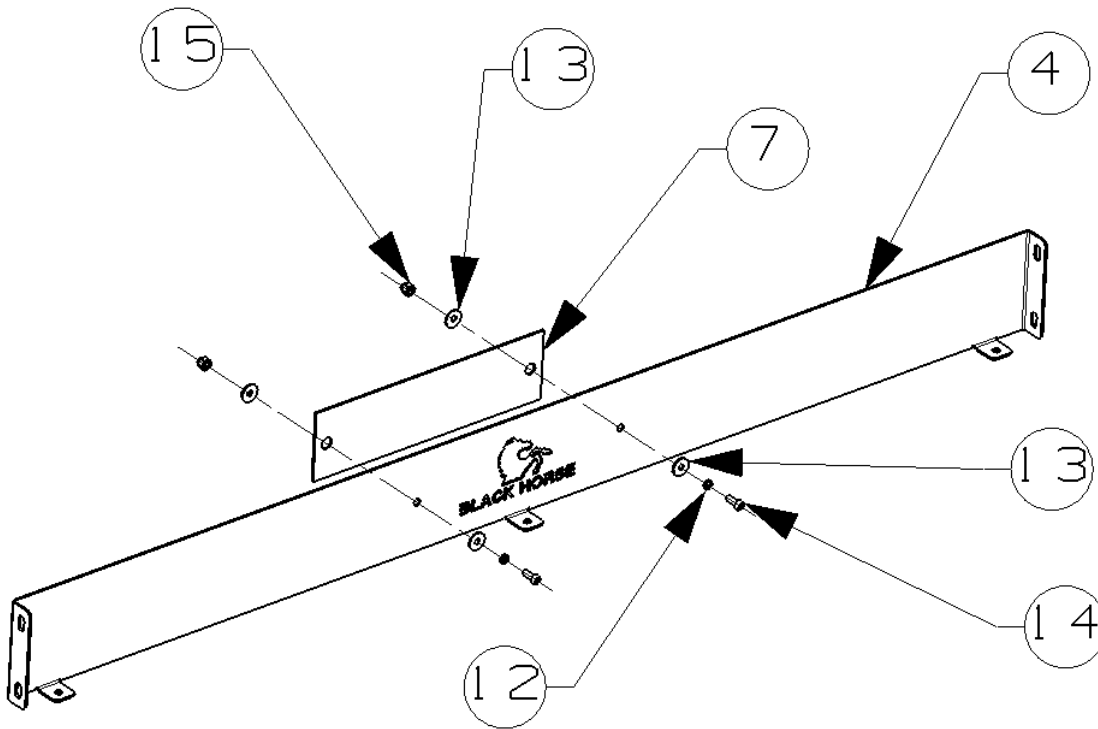
Step 1: Install the red decoration plate in sequence as below figure shown. If rear plate has no logo, do not need to install the red decoration. Use hardware ⑫⑬⑭⑮ to install ④Rear Plate with ⑦Red Decoration Plate.

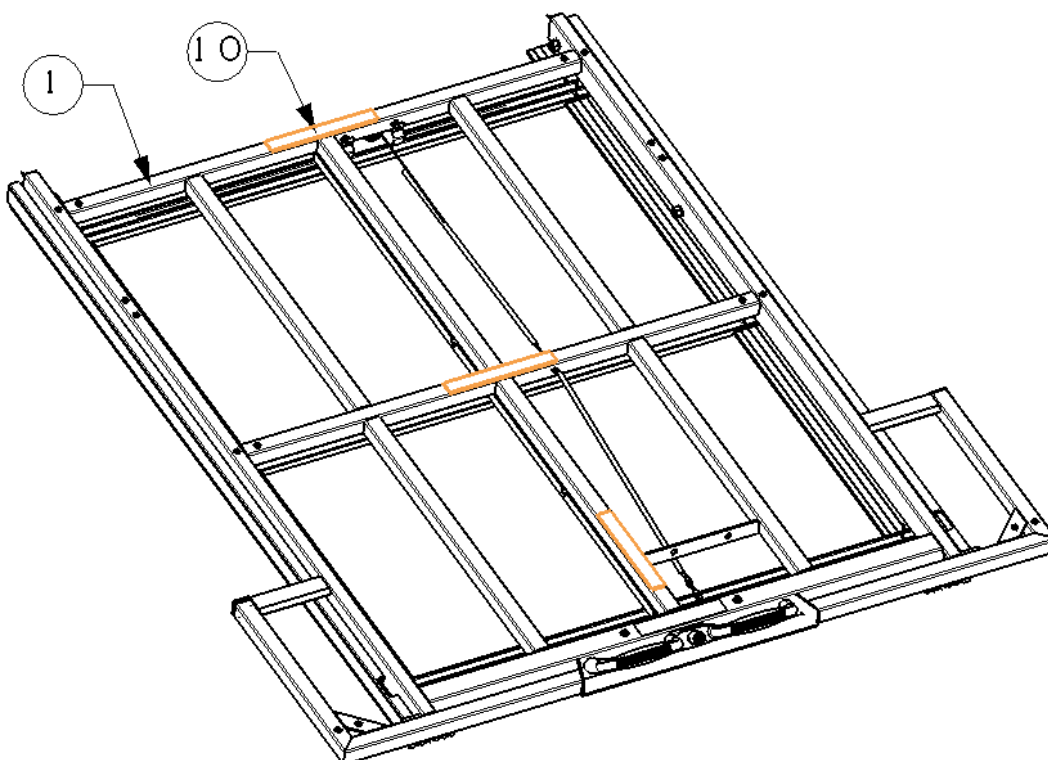
Step 2: Stick ⑩Tapes on ①Base Of Slide Tray.

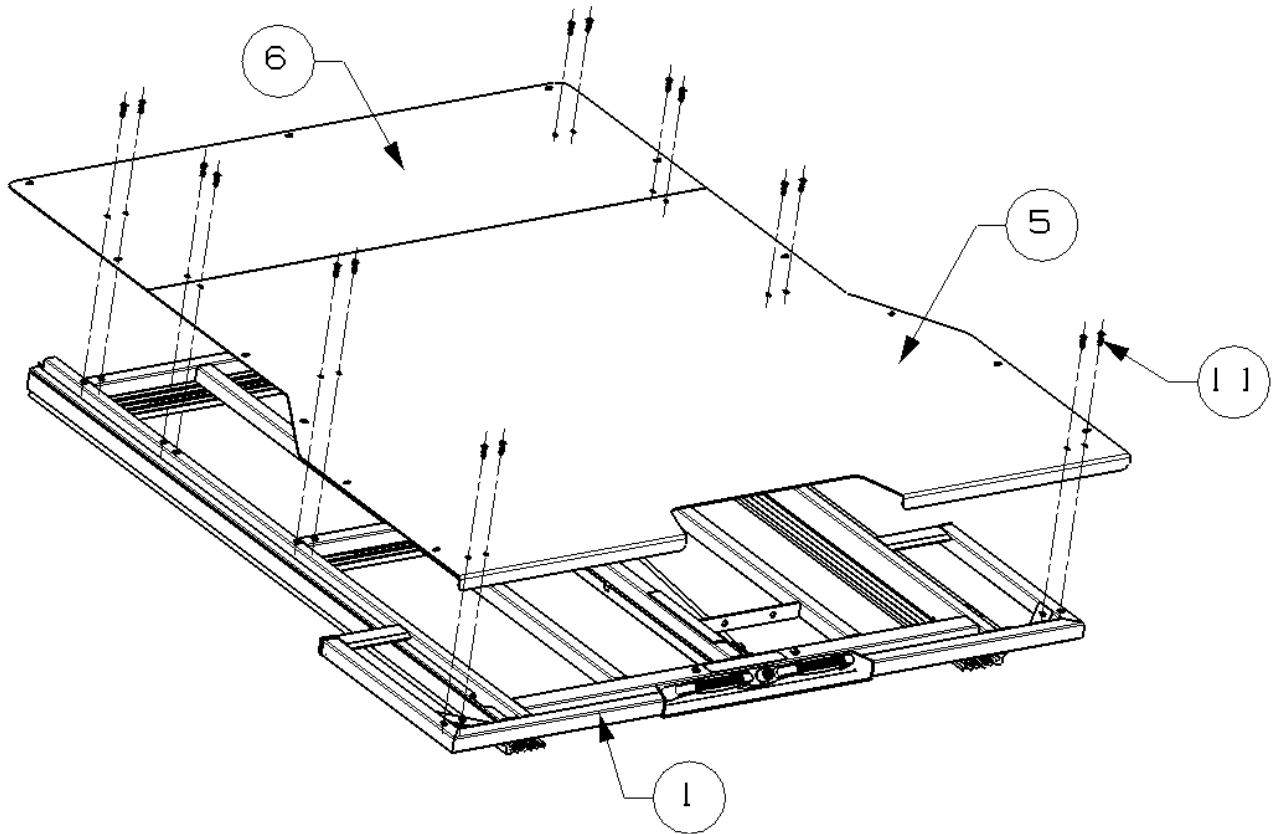
Step3: Use ⑪Hex Flat Head Bolts M6\_20 to install ①Base Of Slide Tray with Base Plates⑤⑥ in

TOTALINER SLIDING CARGO TRAY FOR FULL-SIZE PICKUPS (FORD F150 5.5'&6.5' Bed 15+/  
DODGE RAM 1500 5.5'Bed 09+/CHEVY SILVERADO 1500 5.9' Bed 15+/TOYOTA TUNDRA 5.5' Bed 14+)  
sequence as below figure shown.

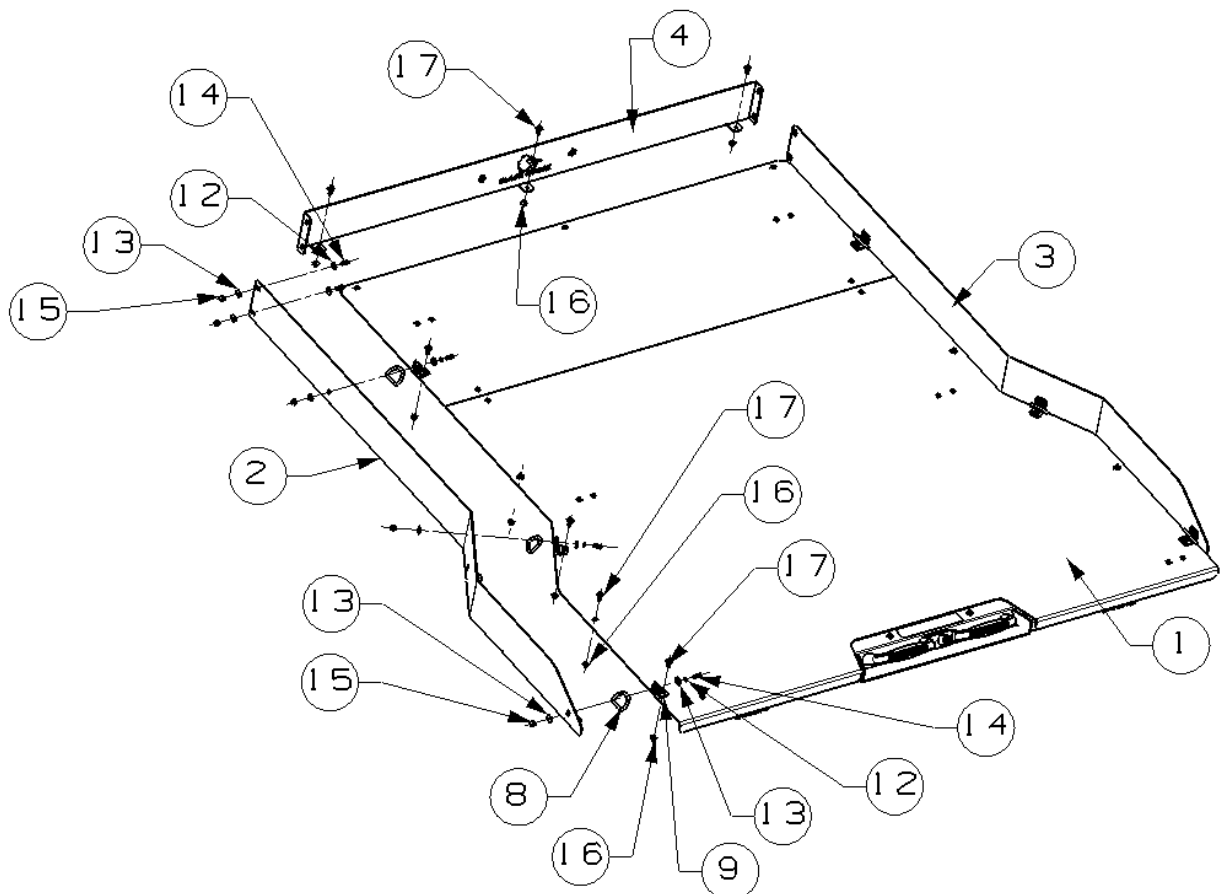
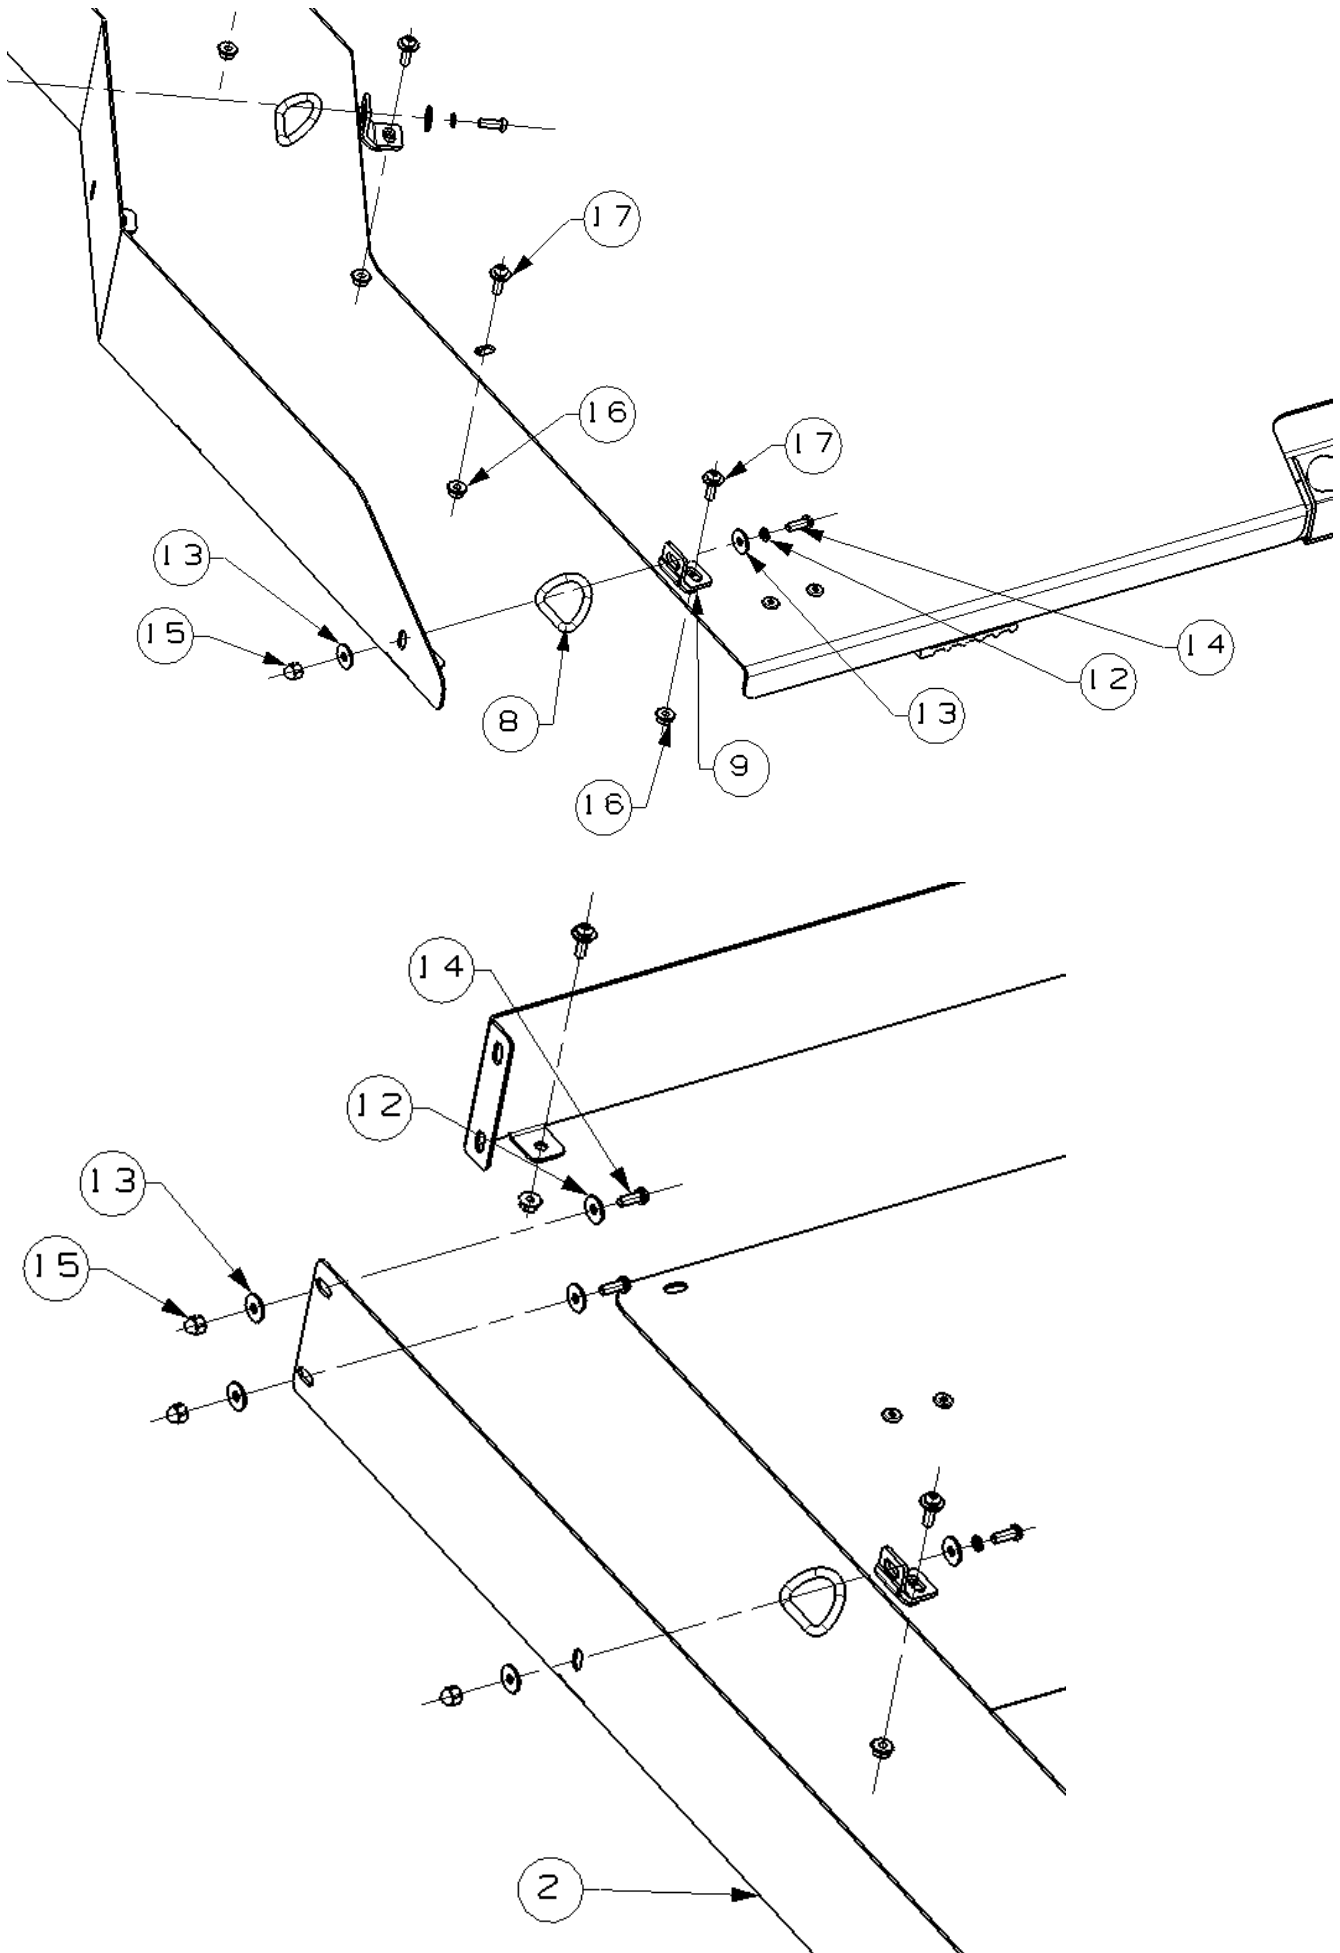
Step4: Use below hardware to install Side Plates②③ and ④Rear Plate.

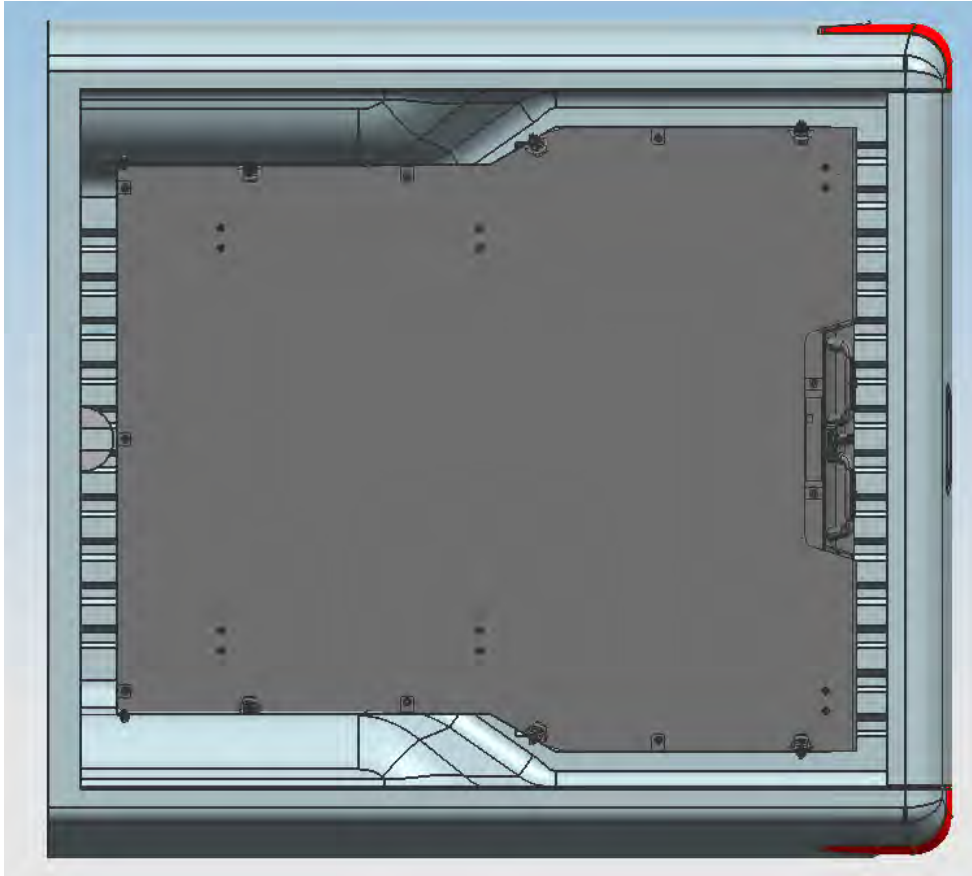
Step5: Put the base and plate of slide tray on the truck bed, adjust it to appropriate position.

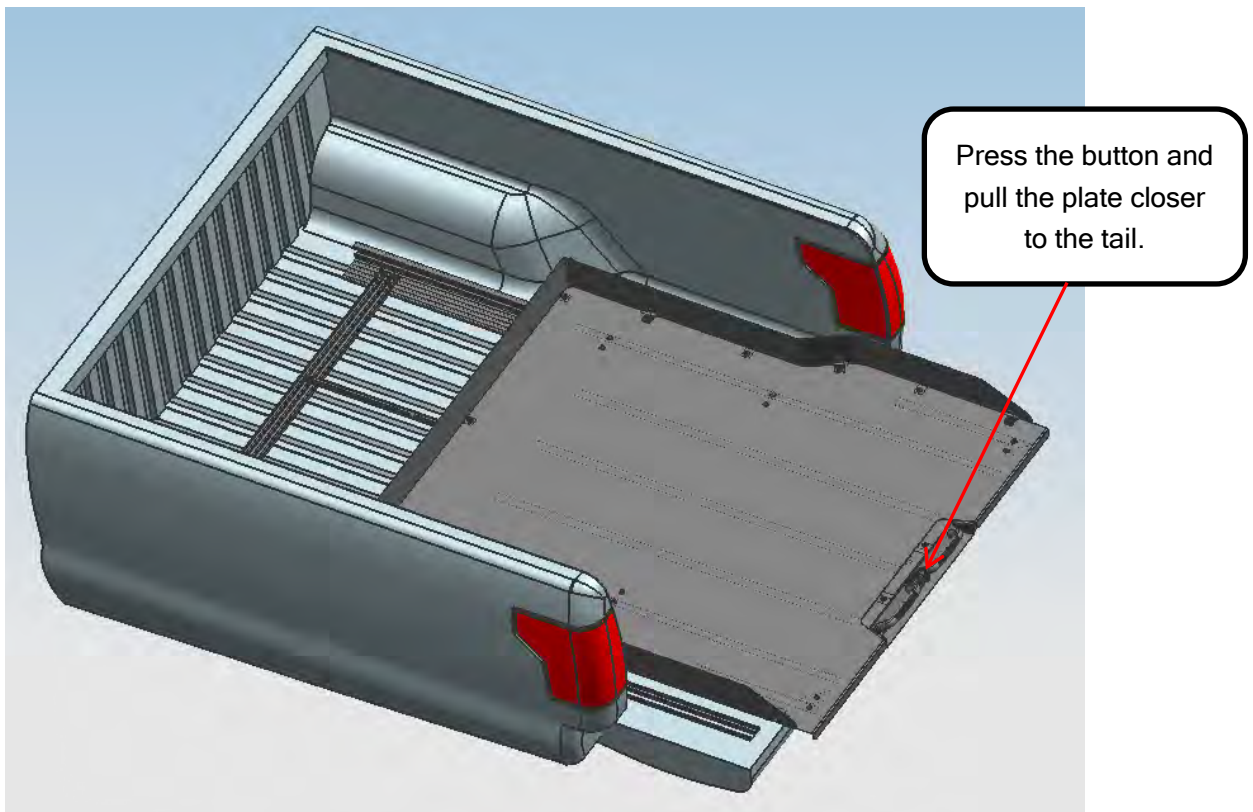
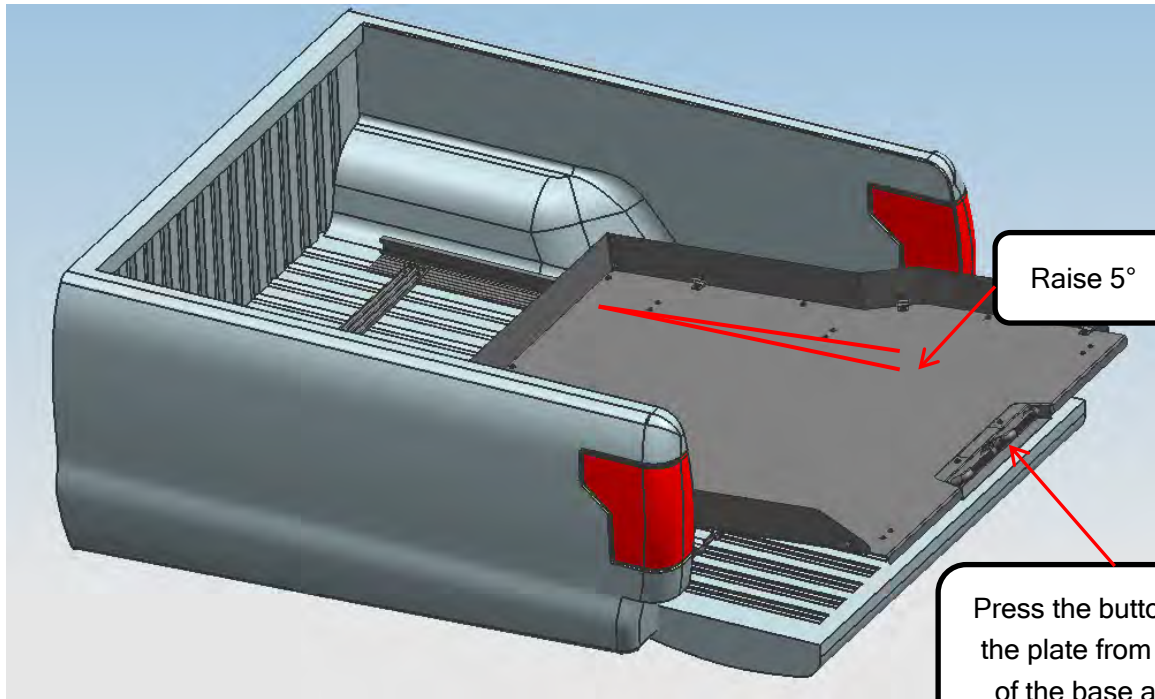
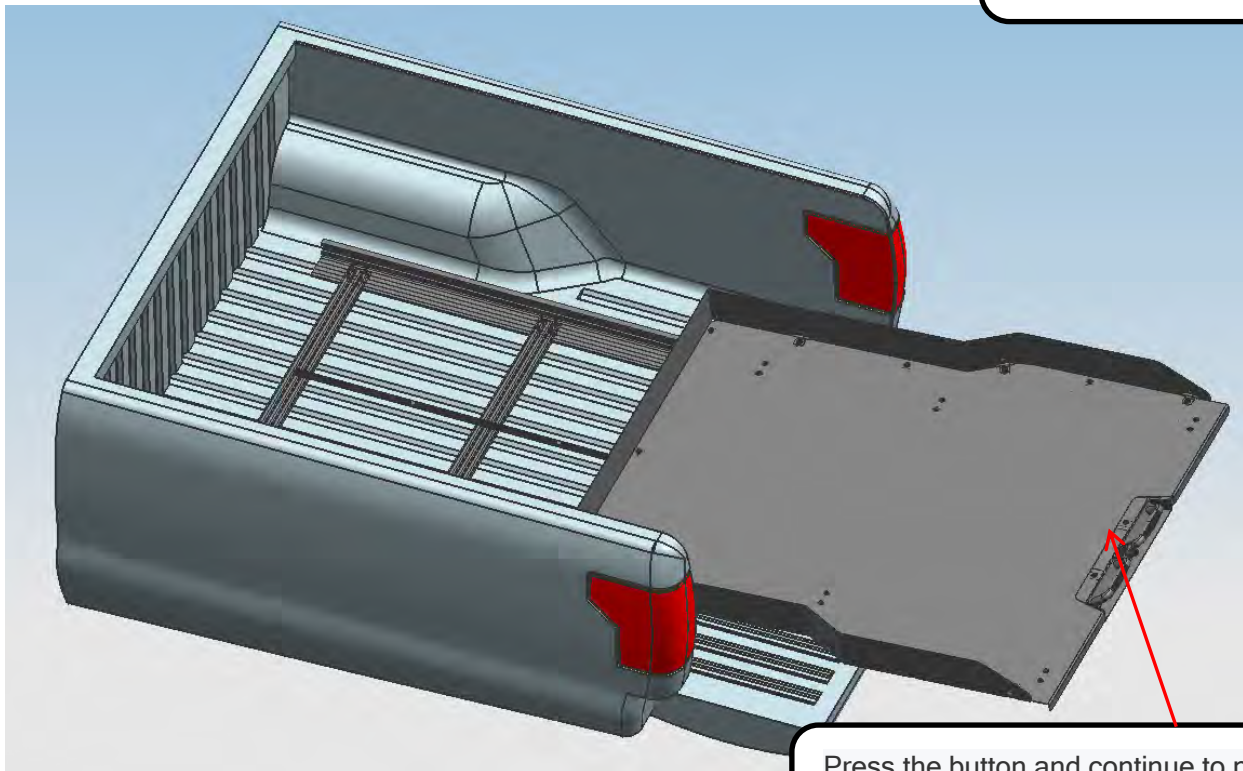
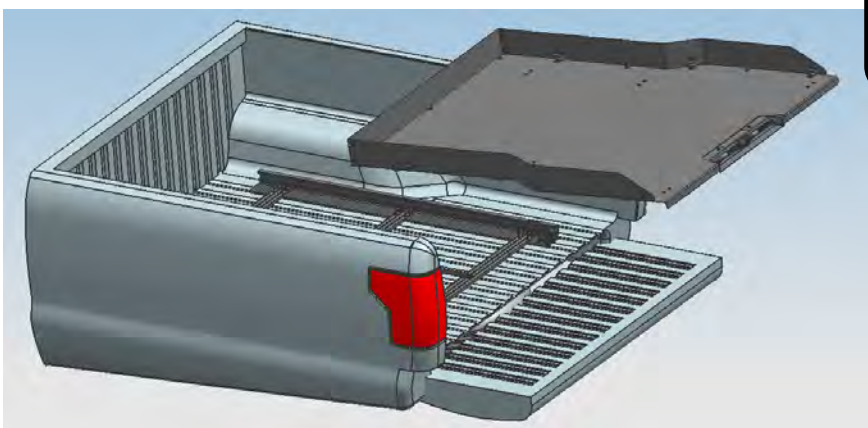
Step 6: After the position is adjusted, remove the plate of slide tray from the base in sequence as below figures shown.

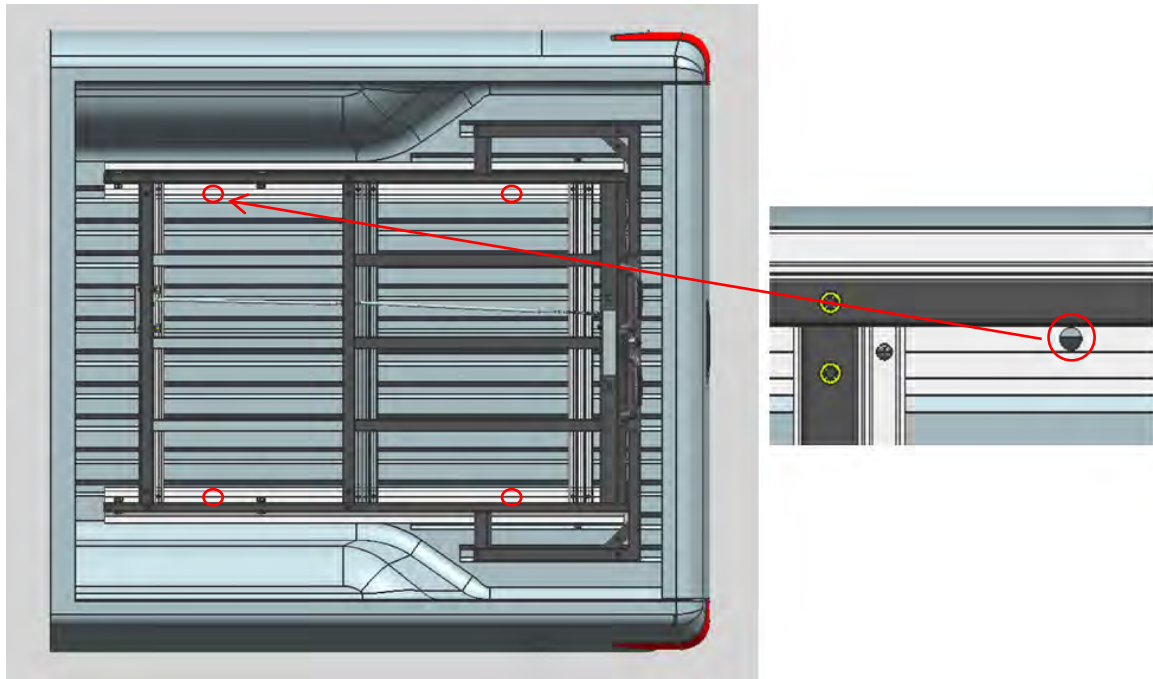
Step 7: Mark the holes position on the base and then drill 4 holes (ø12mm) on the aluminum base as the figure shown below. Holes on each side should be kept in same distance. Then drill the same holes position on the truck bed.

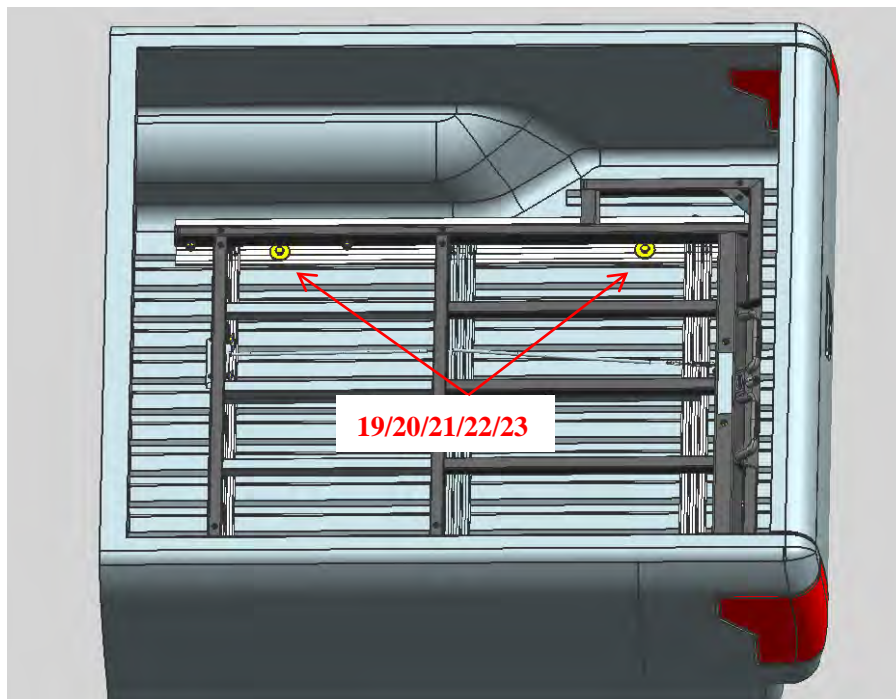
Step 8: Install the ①base of slide tray on the truck bed with hardware⑱⑳㉑㉒㉓.

Step 9: Reinstall the plate on the base.

Step 10: Test and make sure that the slide tray is steadily fixed, fully tighten all hardware.
